CONTINUING ELIGIBILITY INSPECTION (CEI) REPORT
FOR FLOOD CONTROL PROJECTS

1. **Project Name:** Kawainui Marsh Flood Control Project
2. **Date of Inspection:** December 18, 2002
3. **Inspection Personnel:**

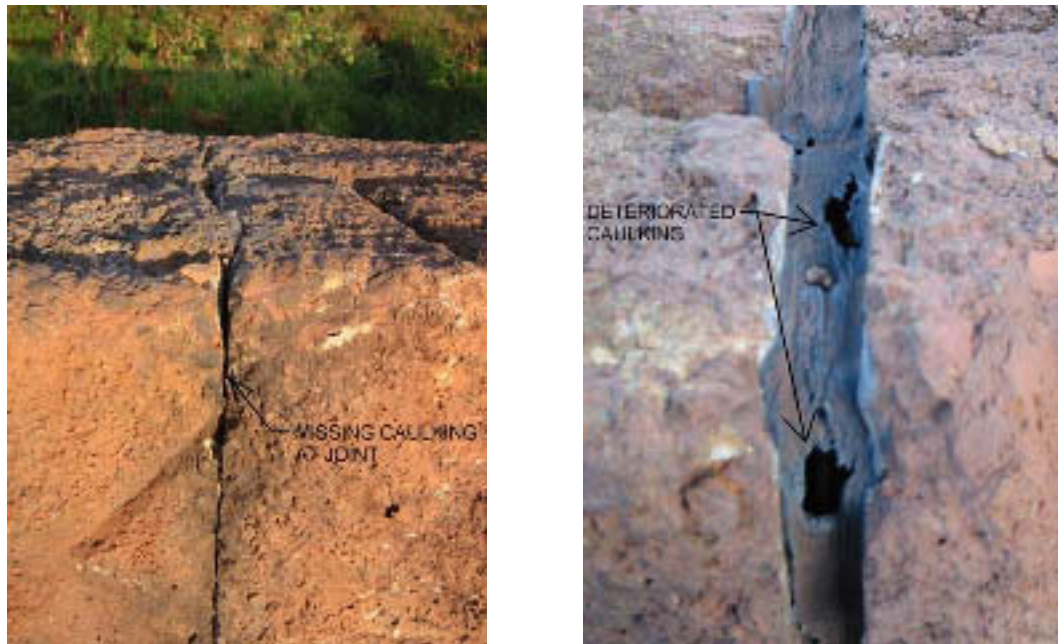
- a. General comment ~ Remove and replace caulking at various joints as needed
®. Example taken from two separate joints at approximately station 62+50.

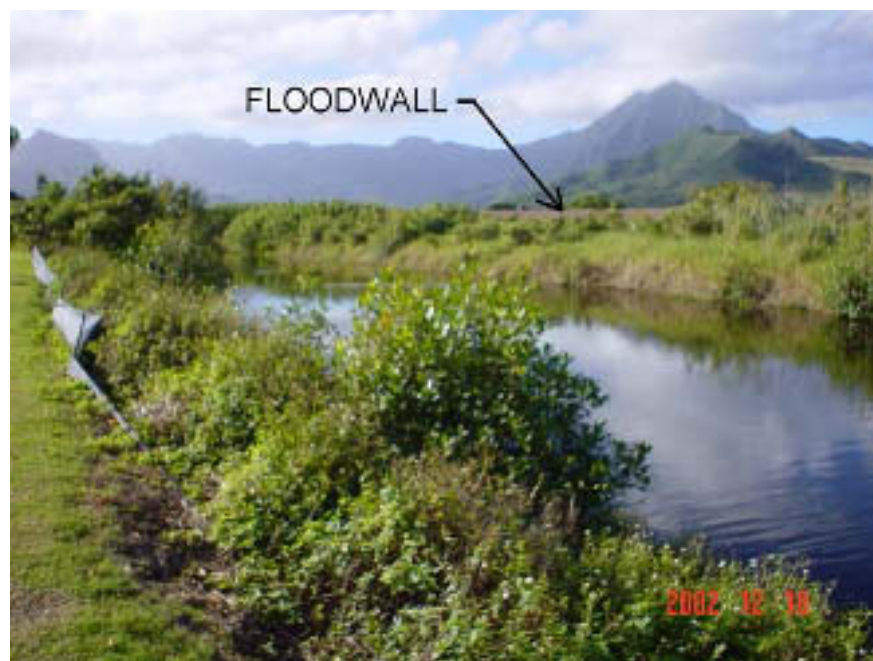
- b. Sta. 63+00, TS (Town Side), overview of floodwall.

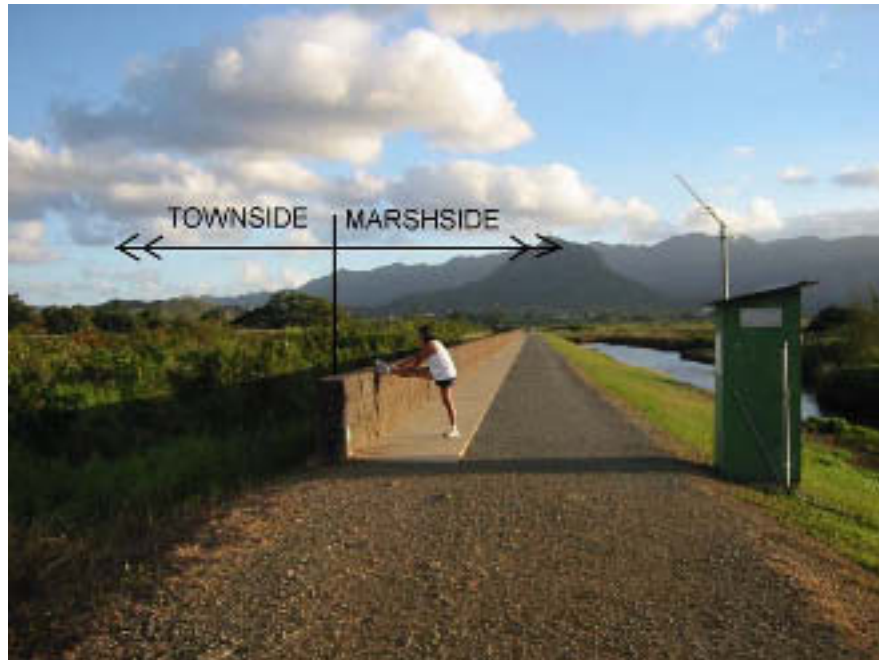
c. Sta. 64+00, Overview of floodwall.

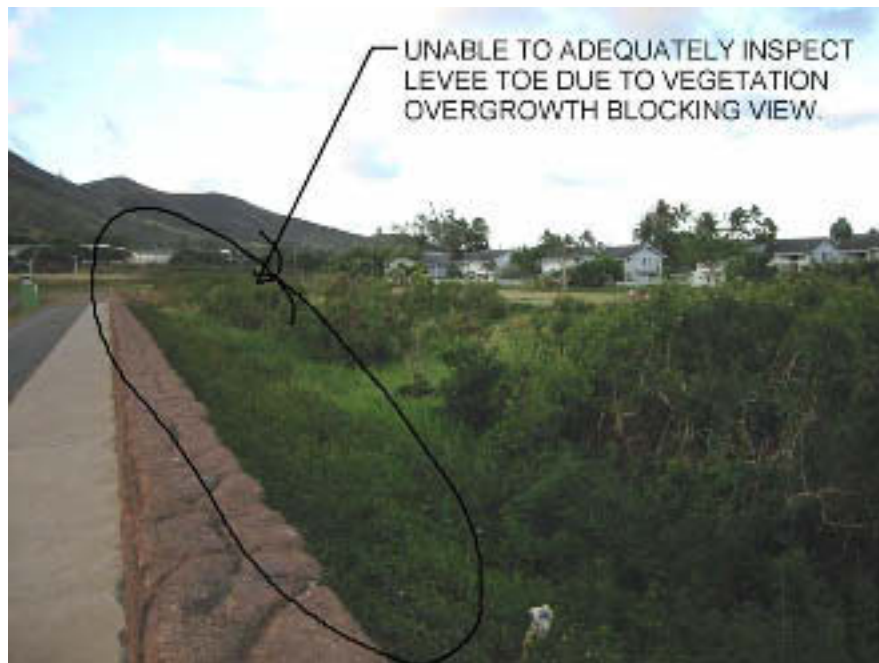
c2. Sta 63+05, Remove vegetation on townside along levee rock wall - unable to adequately inspect toe ®.

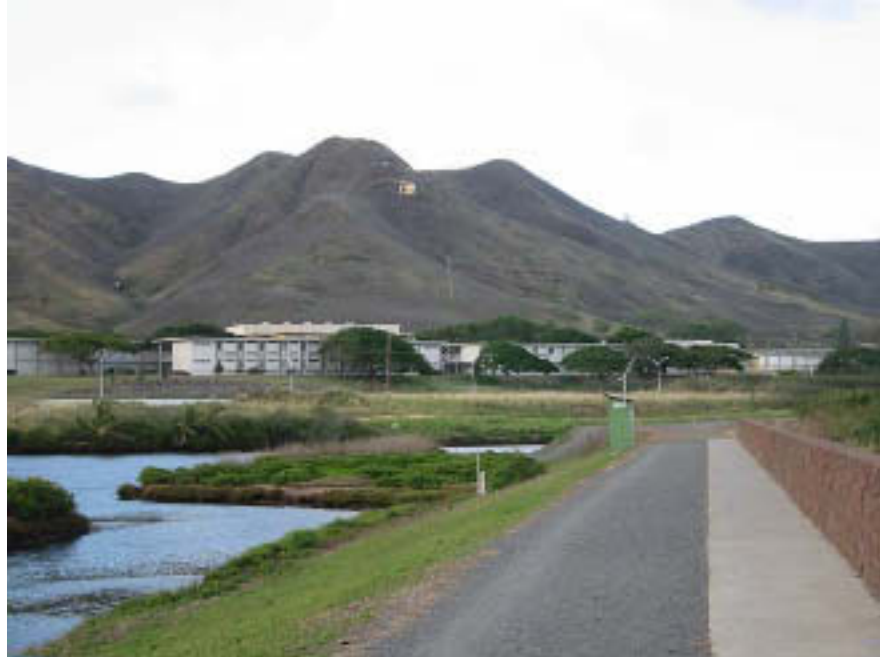
c3. Sta. 63+00, Overview.

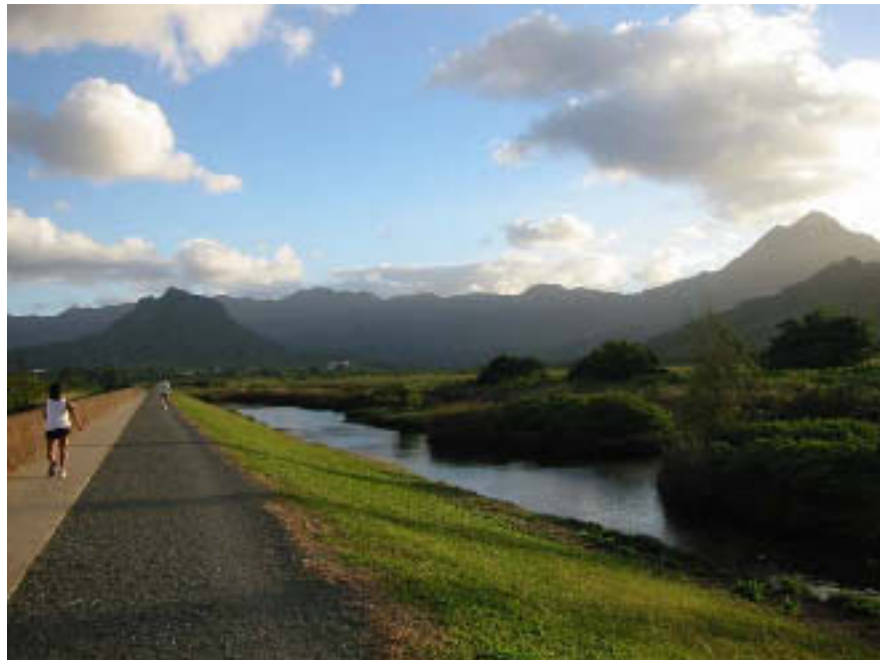
c4. Sta. 62+00, Overview.

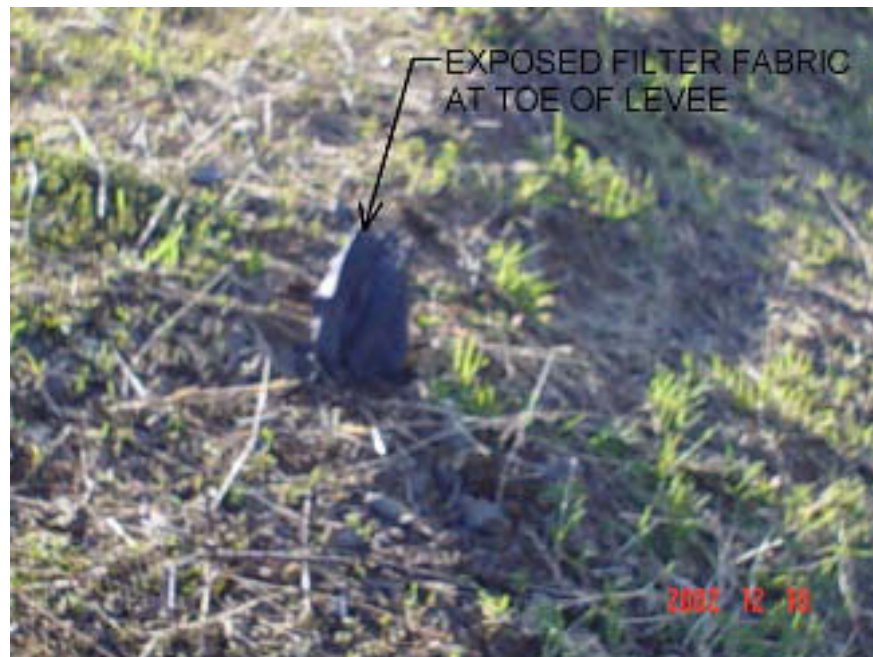
d. Sta. 61+25, MS (Marsh Side), backfill and cover exposed filter fabric at toe of levee.

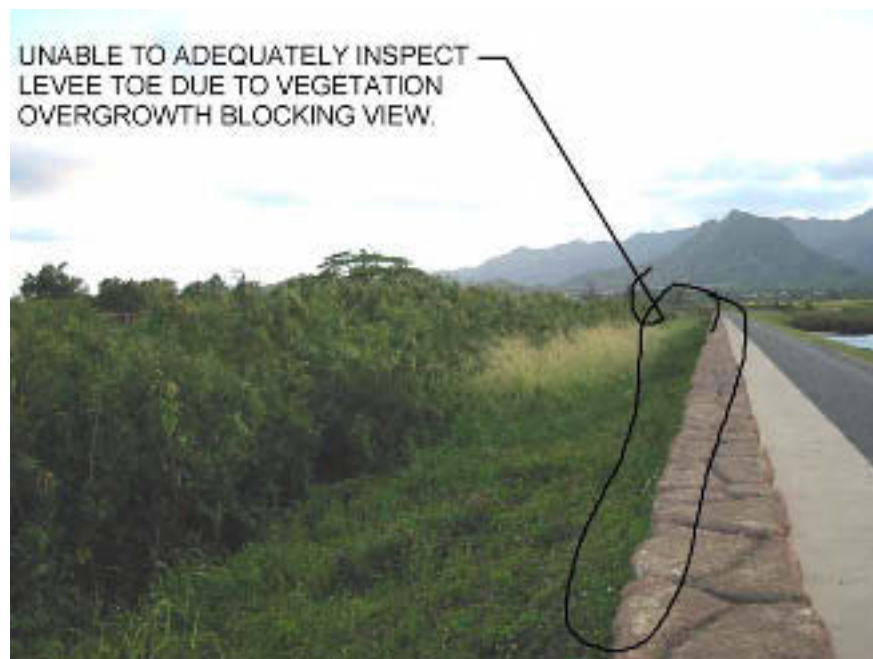
d2. Sta. 60+00, Remove vegetation on townside along levee rock wall - unable to adequately inspect toe ®.

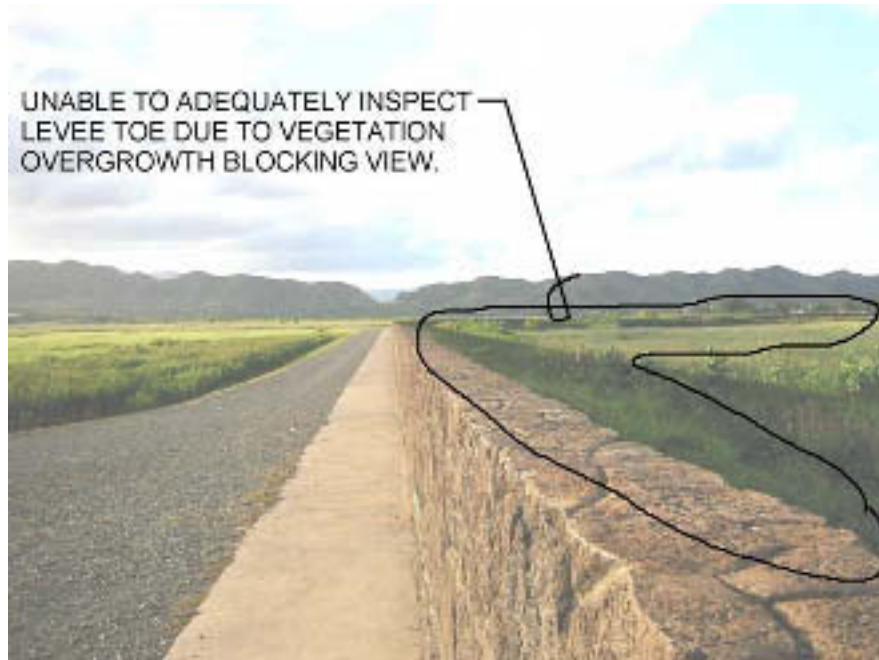
d3. Sta. 21+00, Remove vegetation on townside along levee rock wall - unable to adequately inspect toe ®.

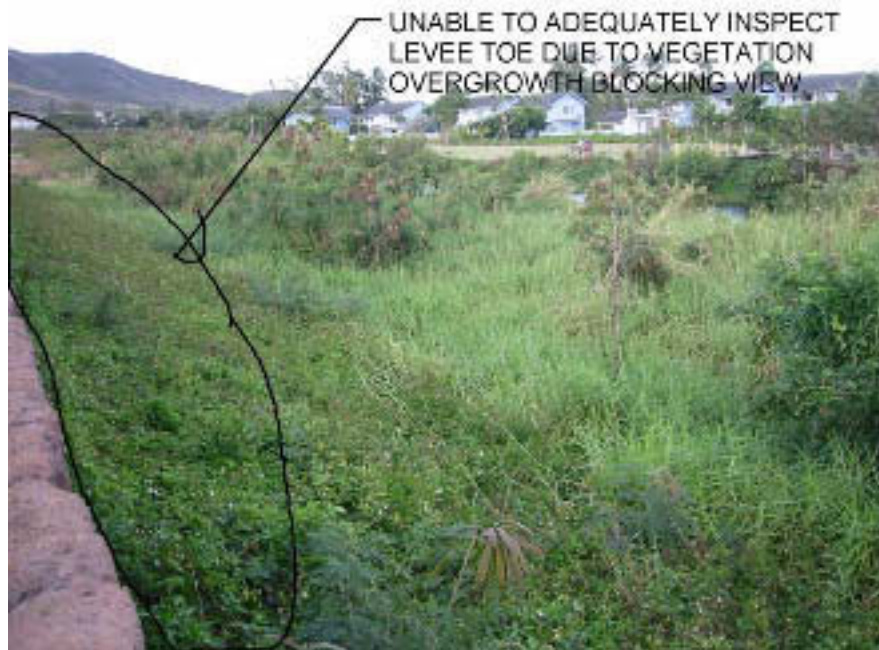
d4. Sta. 20+00, Remove vegetation on townside along levee rock wall - unable to adequately inspect toe ®.

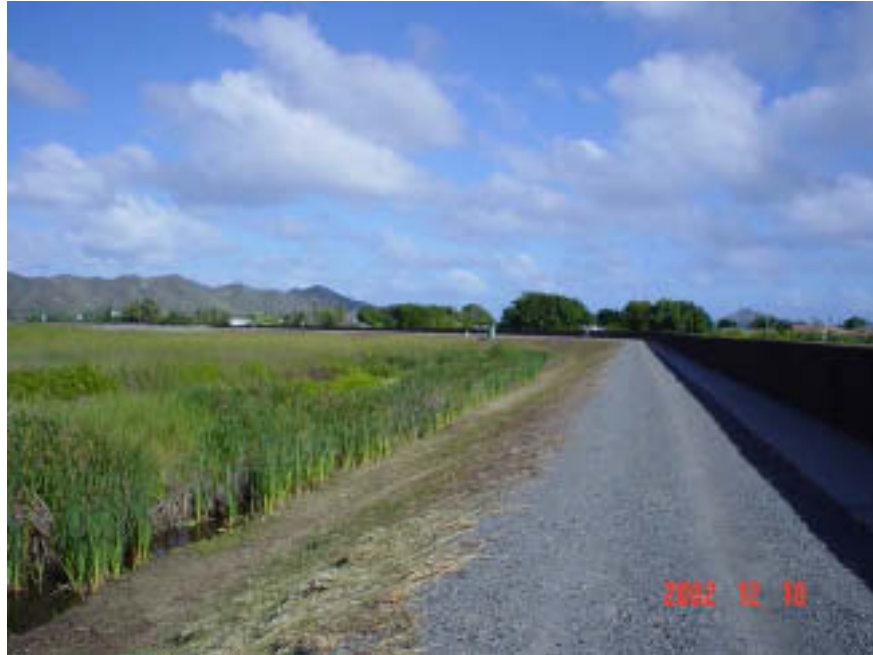
e. Sta. 18+00, MS, overview.

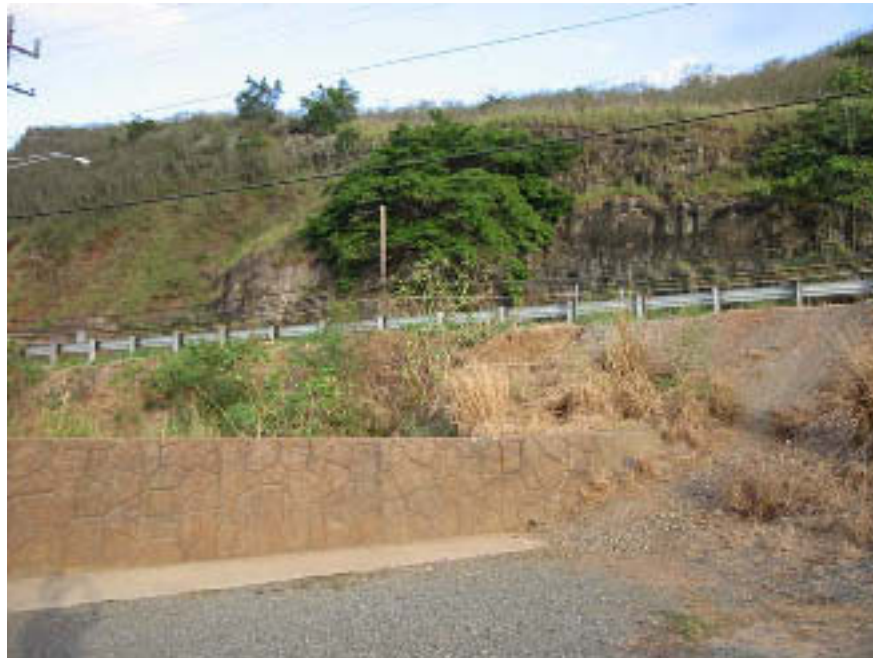
e2. Sta. 0+00, Overview.

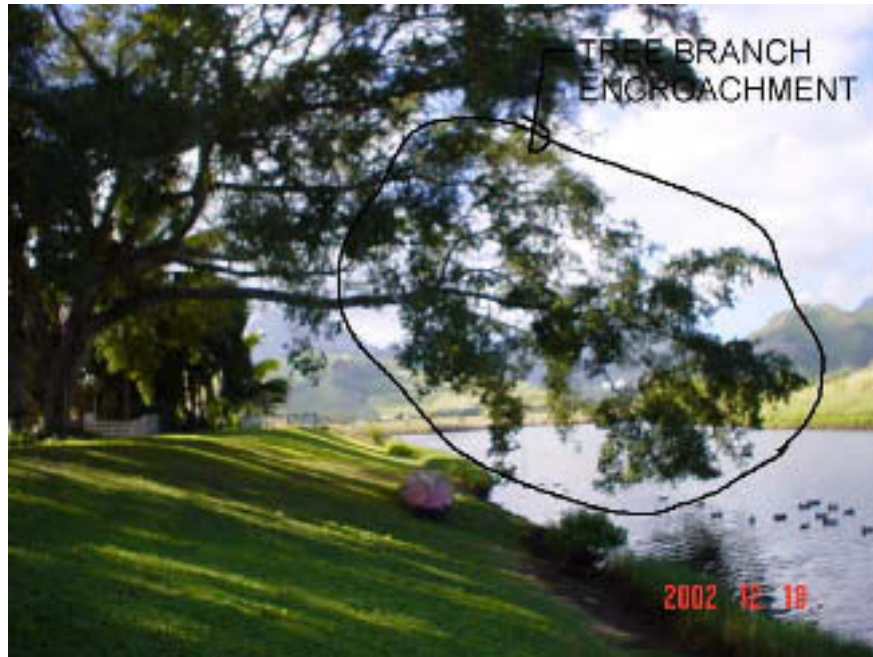
f. Sta. 90+00, RB, trim tree branch encroachments.

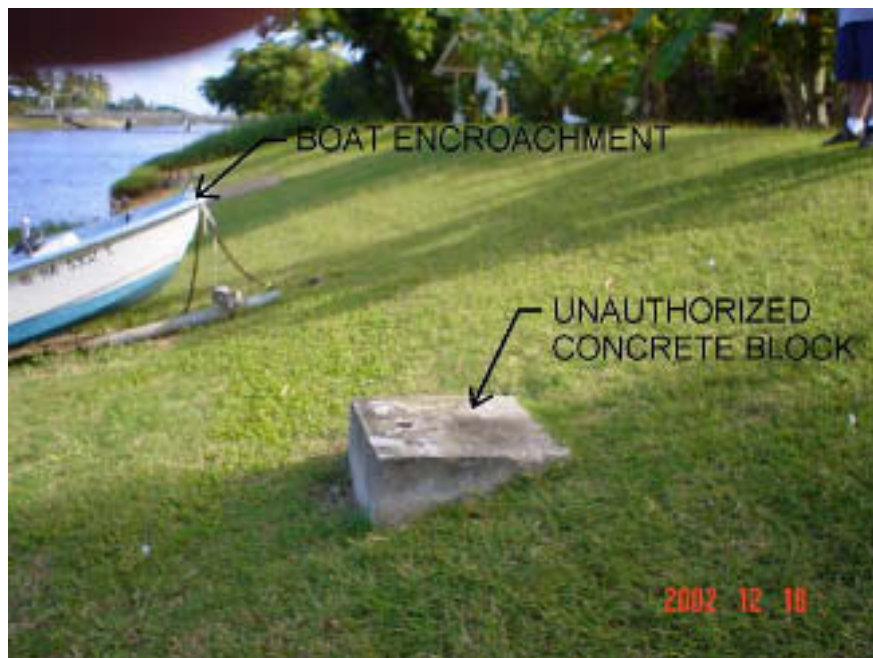
g. Sta. 89+00, RB, remove all unauthorized concrete blocks (typical). Move all boat encroachments away from channel slope (typical).

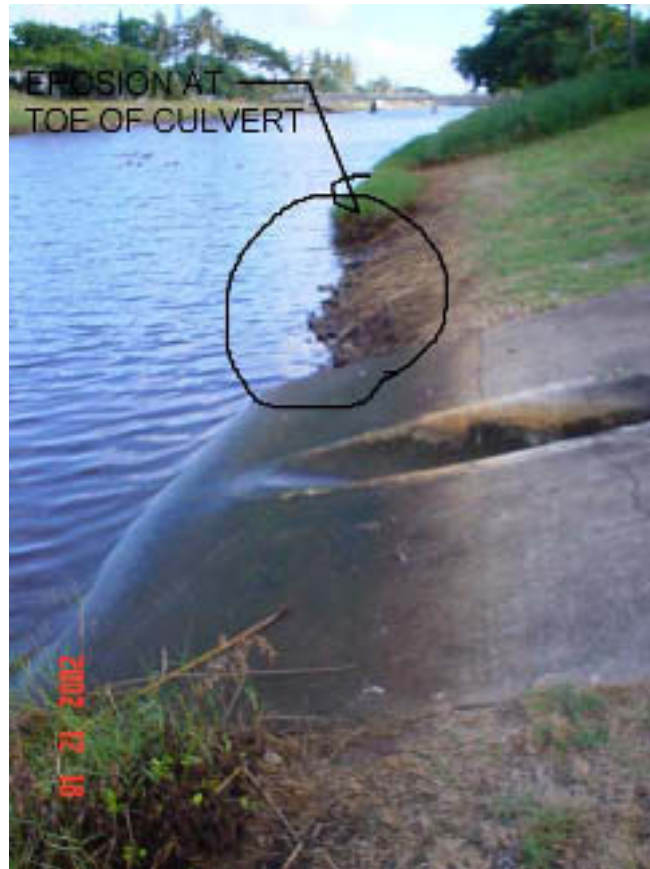
- h. Sta. 88+00, RB, fill eroded area adjacent toe of culvert. Recommend riprap.

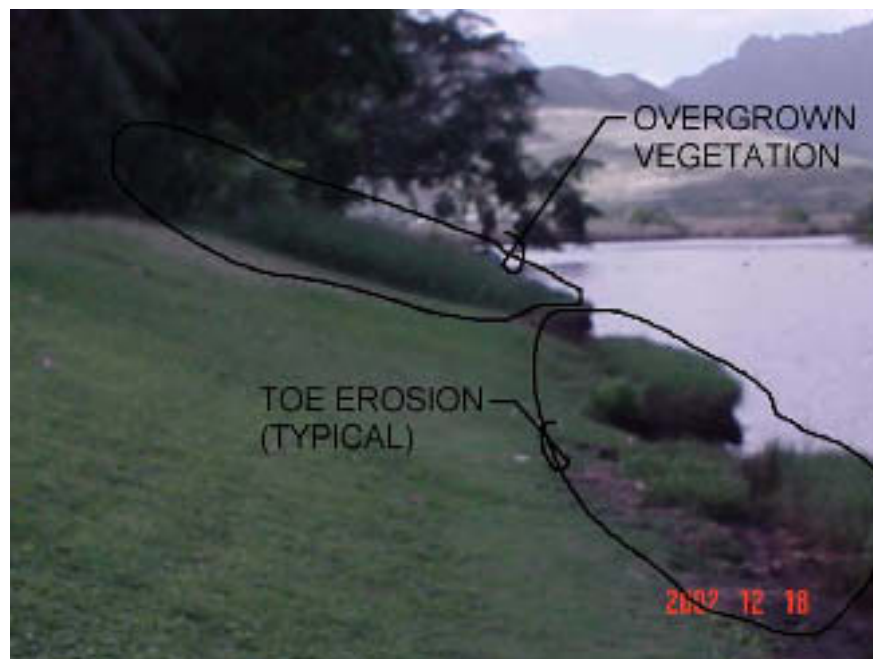
- i. Sta. 87+00?, RB, remove overgrown vegetation and fill all eroded toe of banks.

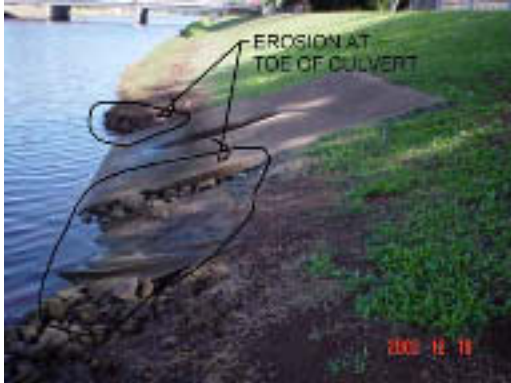
j1. Sta. 86+50, RB, fill erosion adjacent eroded toe of culvert upstream Oneawa Bridge. Recommend rip-rap.

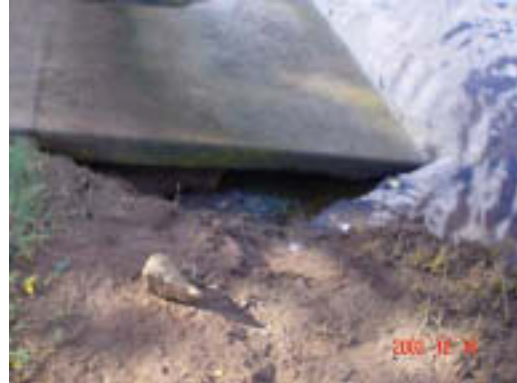
j2. Sta. 86+50, RB, enlargement of area; undermining.

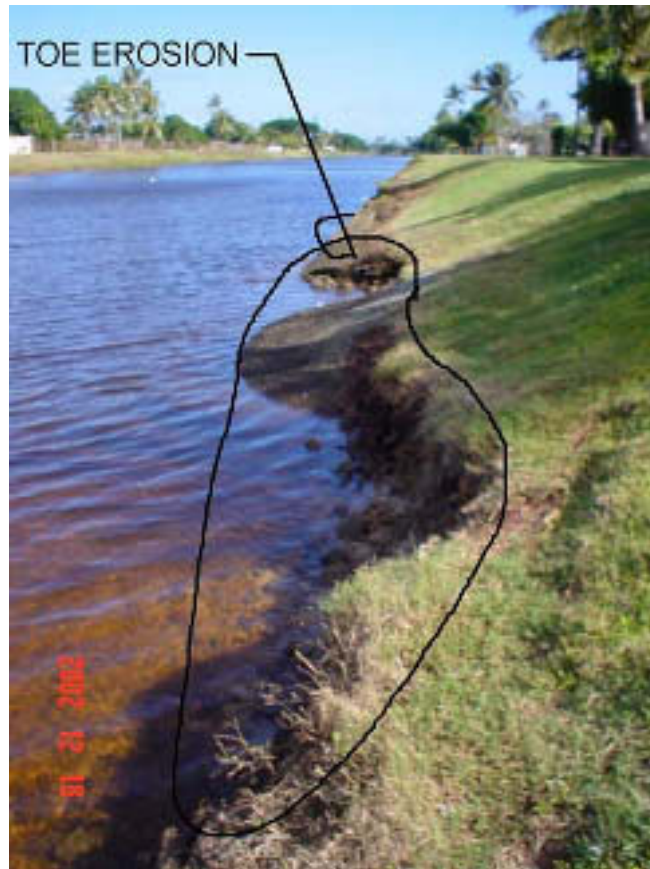
k. Sta. 80+00, RB, fill in eroded bank toe. Recommend rip-rap.

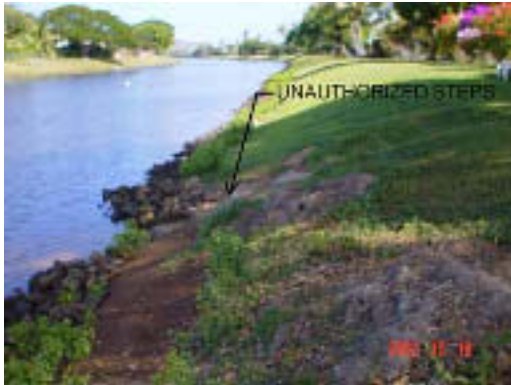
L1. Sta. 61+50, RB, remove unauthorized steps.

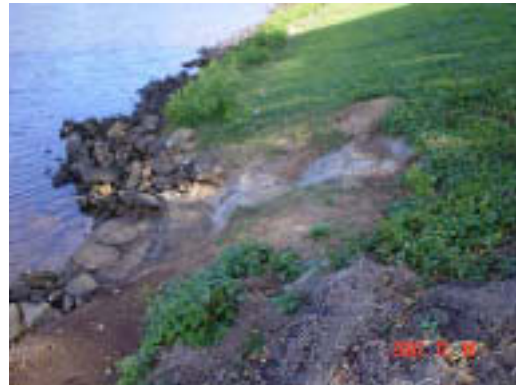
L2. Sta. 61+50, RB, enlargement.

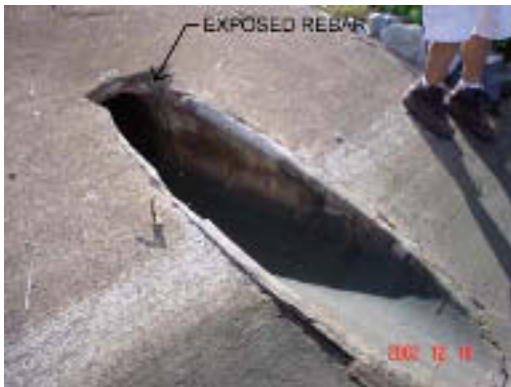
m1. Sta. 47+75, RB, patch damaged culvert; rebar exposed.

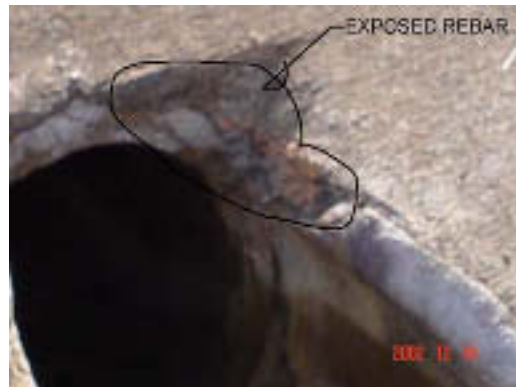
m2. Sta. 47+75, RB, enlargement.

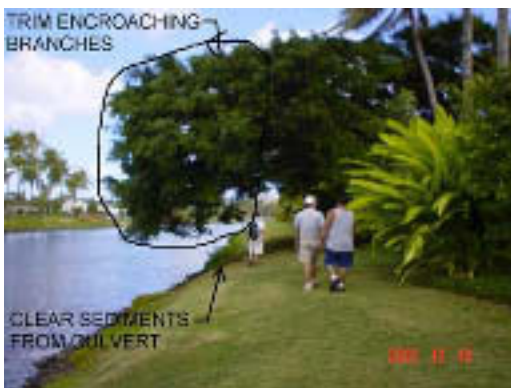
n1. Sta. 30+00, RB, remove sediments in culvert headwall. Trim encroaching tree branches.

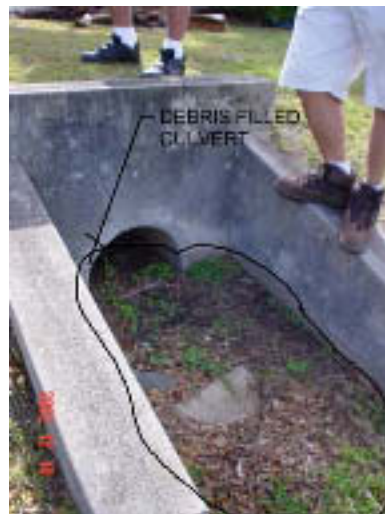
n2. Sta. 30+00, RB, culvert enlargement. Keep culvert clean of debris.

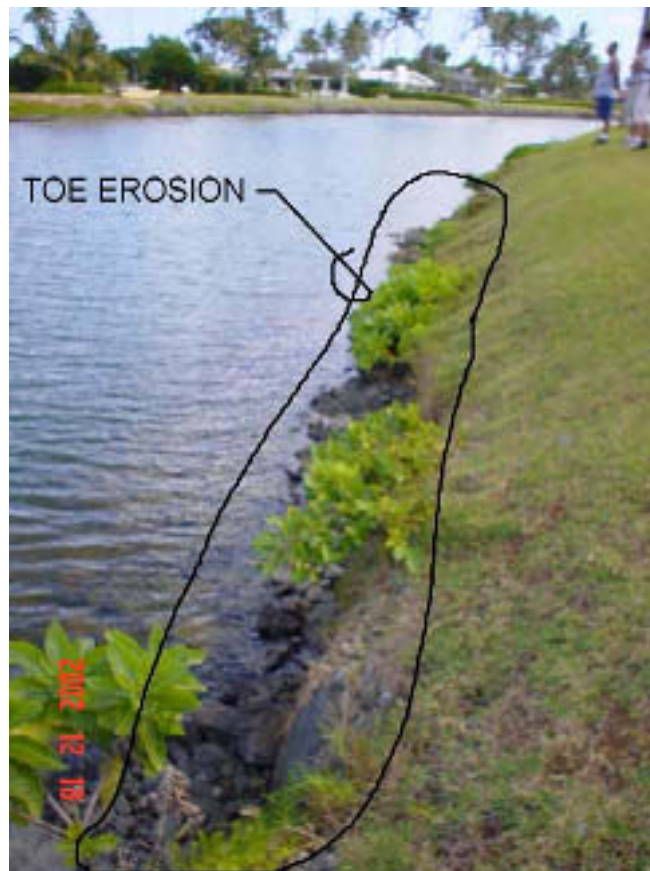
Oneawa Channel RB	14+00	Monitor eroded toe bank. Currently rocks beneath the water adjacent the bank toe alleviates erosion in the area.
Oneawa Channel LB	19+20	Remove unauthorized steps.
Oneawa Channel LB	21+00	Remove unauthorized steps.
Oneawa Channel LB	35+00	Replace unauthorized removal of rocks at toe of bank outside Pinky's restaurant.
Oneawa Channel LB	40+50	Patch cracked culvert headwall
Oneawa Channel LB	45+50	Repair crack in culvert.
Oneawa Channel LB	52+80	Remove debris around culvert headwall and patch the cracked portion of the headwall.
Oneawa Channel LB	61+00	Patch concrete headwall.
Oneawa Channel LB	85+00	Fill eroded toe of culvert headwall.

o. Sta. 14+00, RB, monitor eroded toe area within 1 Kailuana Place. Currently rocks beneath the water adjacent the bank toe alleviates erosion in this area.

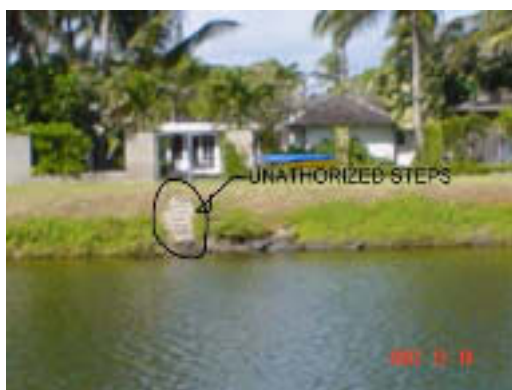
p1. Sta. 19+20, LB, remove unauthorized steps.

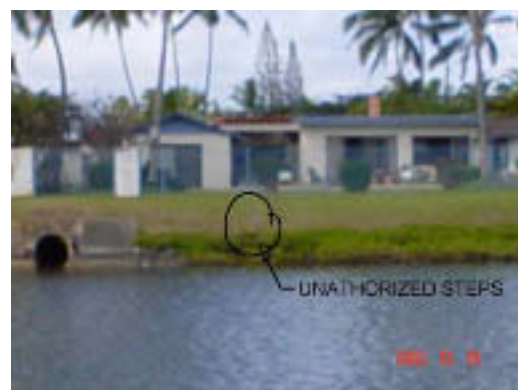
p2. Sta. 21+00, LB, remove unauthorized steps.

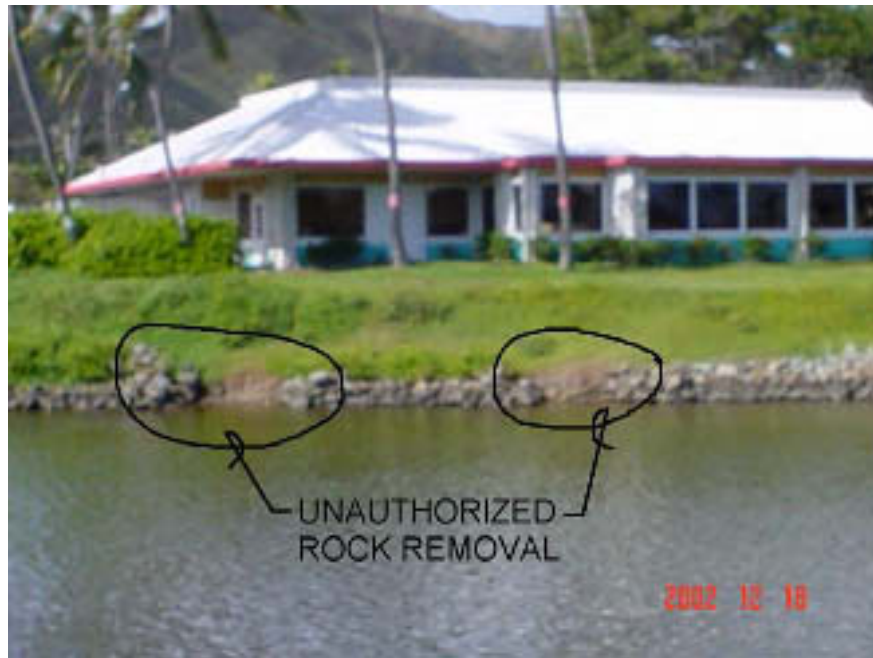
q. Sta. 35+00, LB, replace unauthorized removal of rocks at toe of bank outside Pinky's restaurant.

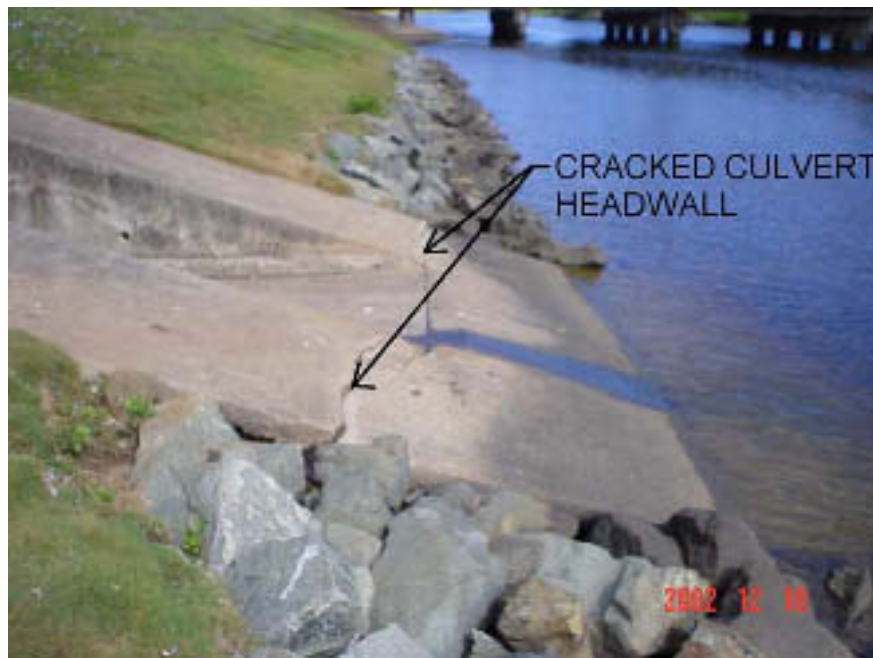
r. Sta. 40+50, LB, patch cracked culvert headwall.

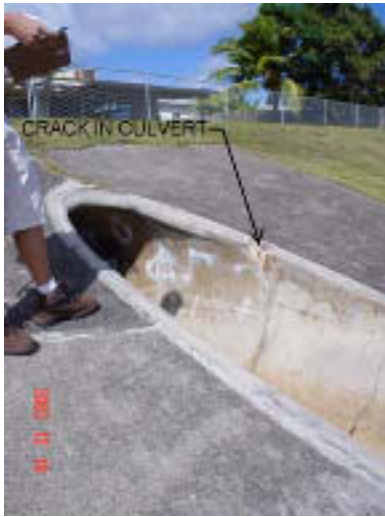
s1. Sta. 45+50, LB, repair crack in culvert.

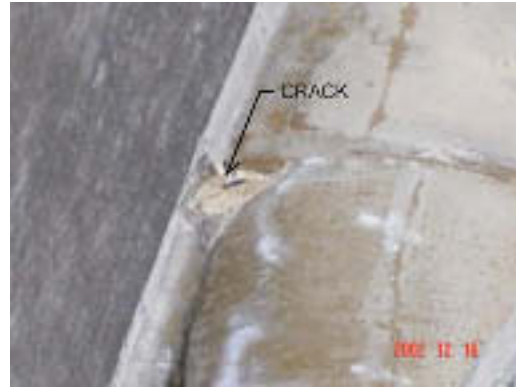
s2. Sta. 45+50, LB, enlargement.

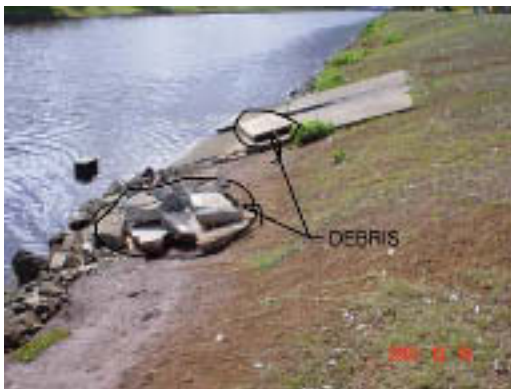
t1. Sta. 52+80, LB, removed debris around culvert headwall.

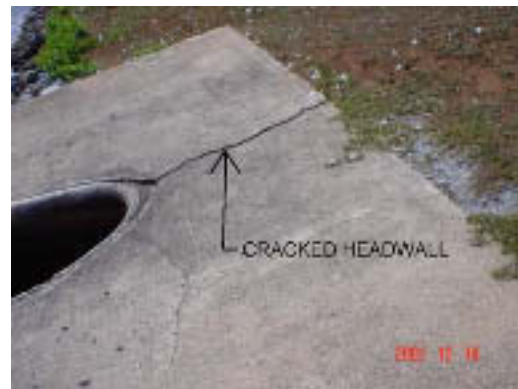
t2. Sta. 52+80, LB patch cracked culvert headwall.

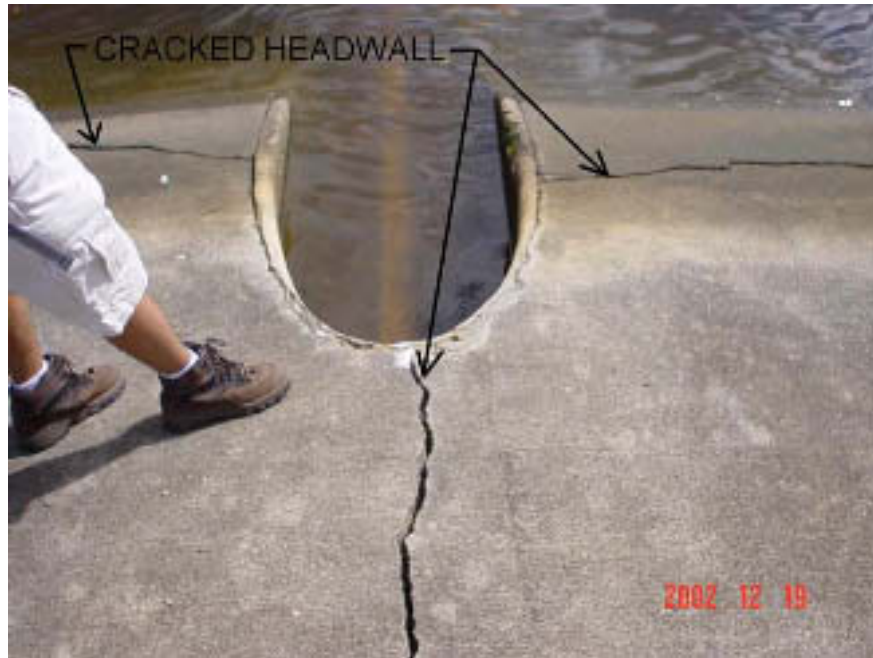
u. Sta. 61+00, LB, patch cracked concrete headwall.

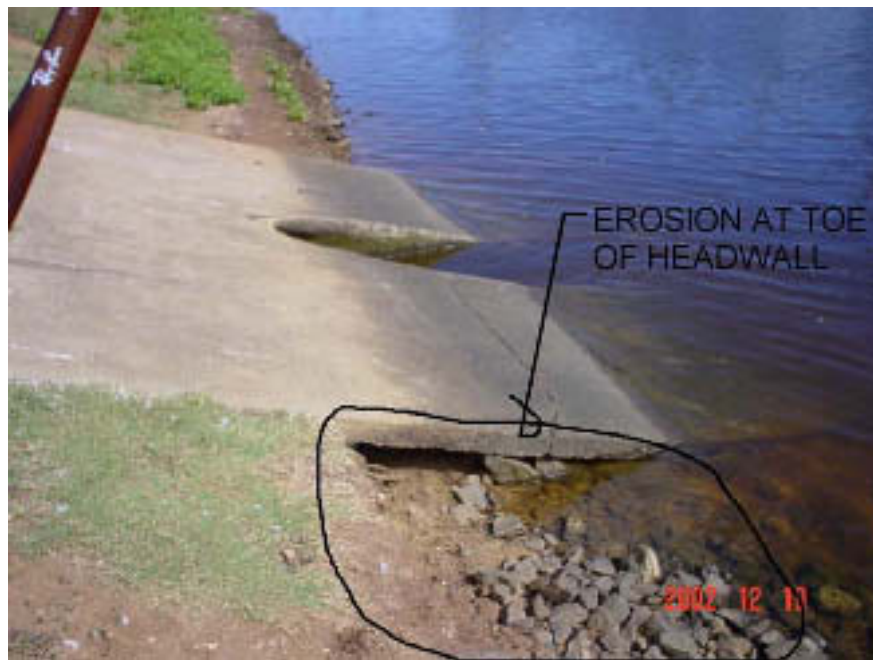
v. Sta. 85+50, LB, fill erosion at toe of culvert headwall. Recommend use of larger rip-rap.
